# SERVICEMEDDELANDE SERVICE MESSAGE

E 93 - 1 to 7

Svenska Aeroplan Aktiebolaget in Trollhättan  
Service Department

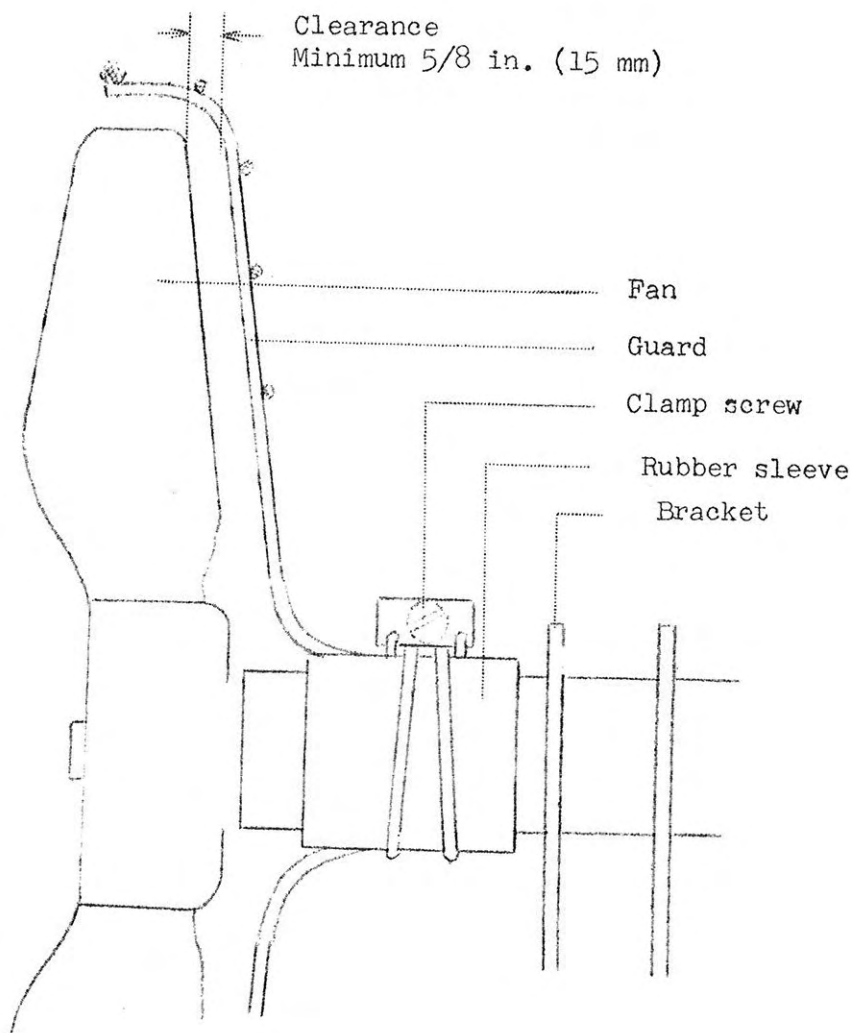
In order to avoid damages to cooling fan and its guard the fan clearance should be checked when servicing cars. If adjustment be required loosen the clamp screw and push the guard and rubber sleeve forward against the bracket. As shown in figure below the clearance should be at least 5/8 in. at the tip of all fan blades. If these measures prove to be insufficient, the edge of the guard may be bent slightly forward until correct clearance is obtained.

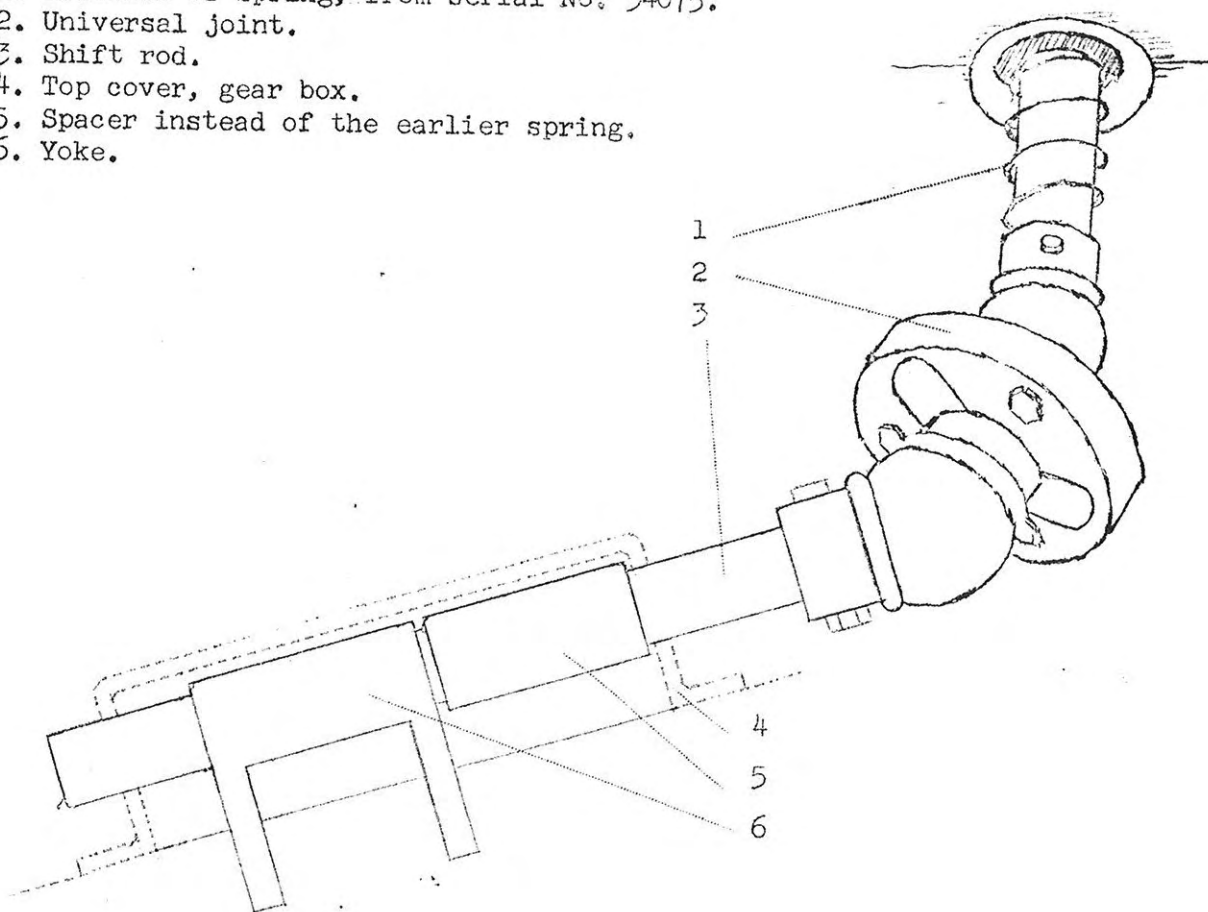
From serial number 34075, the above mentioned spring is modified. The earlier spring (spare part No. 707418), which is cylindric and placed on the shift rod in the gear box top cover, is replaced by a spacer and a new conical spring (710514) has been fitted on the gear shift rod between the universal joint and the firewall, see fig. The reason for this modification is to reduce transplantation of noise from the gear box.

1. Location of spring, from serial No. 34075.
2. Universal joint.
3. Shift rod.
4. Top cover, gear box.
5. Spacer instead of the earlier spring.
6. Yoke.

If a gear box or any part in the gear shift mechanism is to be changed be sure that only one of the return springs is mounted and preferably the one outside the gear box. In case the spring inside the gear box is to be removed, remember to put a spacer, 5, in its place on the shift rod.

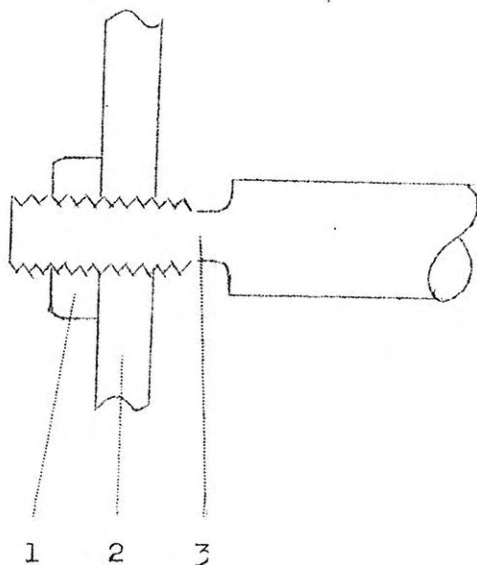
The screw for adjustment of the 2nd - 3rd speed gear shift bar is from serial number approx. 32000 (gear box 32601) integral with the gear shift bar, (see fig. below) and the coil spring at the front end of the bar has been removed. The adjustment of gear shift bar is carried out in the same way as before. - (Service Manual. Chapt. 3 item 4.2.6.2.) As the gear shift bar now will come loose when dismantling the gear box end cover, exercise great care so as not to lose the ball catch and its spring, which are fitted in the gear shift fork.

1. Lock nut
2. Gear box end cover
3. Gear shift bar

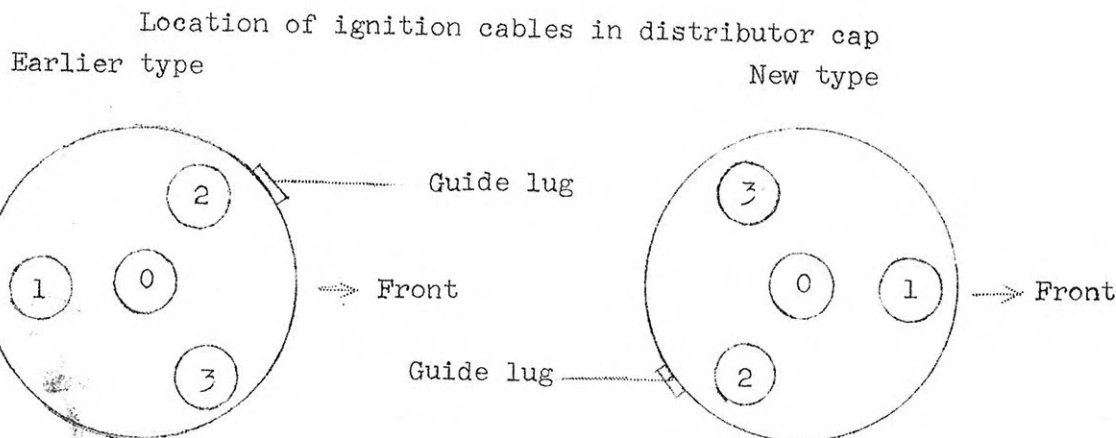
From engine number 39639 (serial number approx. 38300) the ignition distributor is modified and its cap is guided by a lug on the rear clamp spring bracket, i.e. it is turned 180°. Thus the ignition cables are now positioned as shown in the figs. below. The condenser and primary cable terminal are situated on the rear side of the distributor body, and the protective cover under the rotor is removed. In consequence of these modifications the marking on the distributor for ignition timing is now situated to the left of the rear spring clamp bracket, i.e. the guide lug. When the piston in cyl. no 2 is at its TDC the rotor should thus point rearwards, which is quite contrary to the instructions issued concerning the earlier type of distributor. The two different procedures for timing the ignition must not be confused, which is important especially when a distributor is re-installed after having been dismantled.

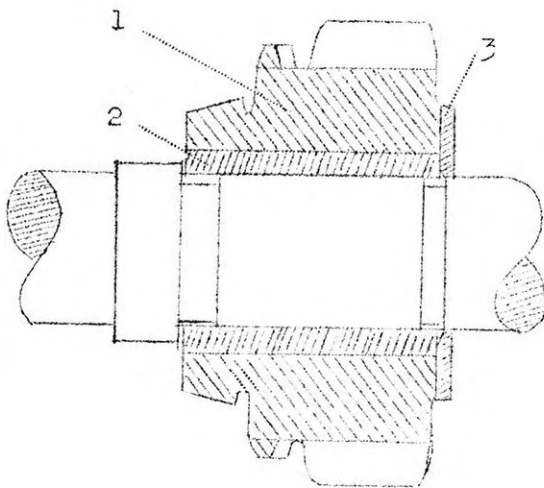
Fig. 1. To gearbox no. 44510.

- 1. 2nd speed drive
- 2. Bushing
- 3. Washer

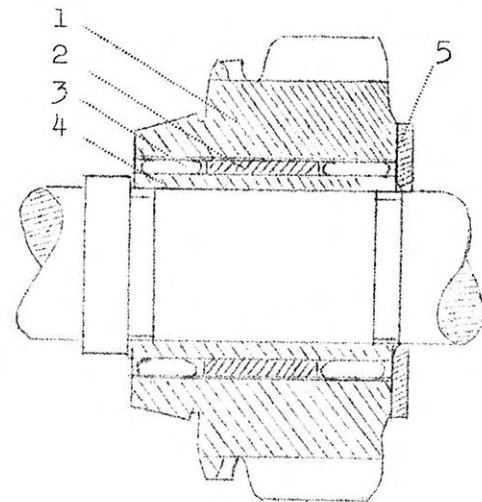
From serial number approx. 42200 (gearbox no. 44511) the 2nd speed drive on the main shaft is equipped with two needle bearings. The bearings are fitted between a new, thinner steel bushing and the modified drive gear. Between the bearings there is a spacer.

Fig. 2. From gearbox no. 44511.

- 1. 2nd speed drive
- 2. Spacer
- 3. Needle bearing
- 4. Bushing
- 5. Washer

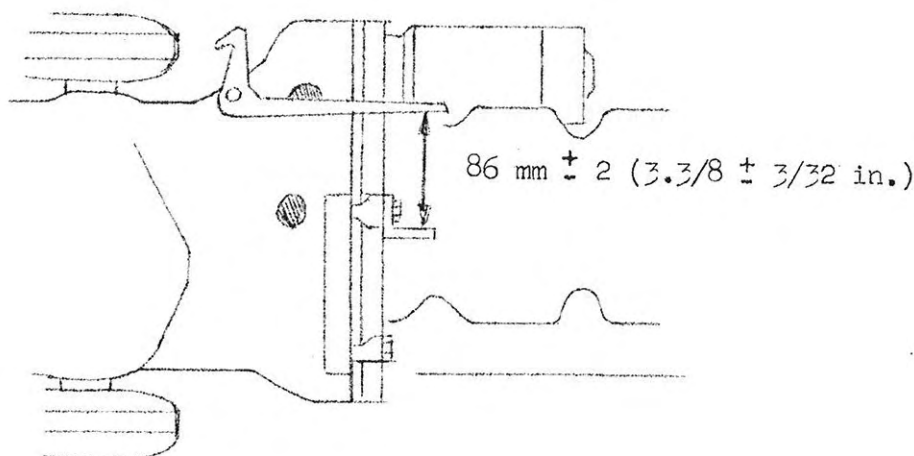
Fig. 1. The power unit as seen from below. - The distance between lever and wire attachment bracket should be 86 mm  $\pm$  2, (3.3/8  $\pm$  3/32 in.).

The distance between the release lever and wire bracket indicated in fig. 1 should be correct, when the lever is forced away from the bracket until there is no play between the release bearing and release plate.

Should the new type of light metal casing be fitted to an earlier type of gearbox, it is necessary to check and adjust the position of the release lever as per fig. 1 below.

Note. This instruction is also applicable to the earlier design of gearbox and should be checked, especially if any release mechanism part, e.g. the release bearing, is replaced. Adjustment of the lever is carried out by bending it carefully until the desired shape is obtained.
